A Study on CEDMCS Stabilization in Hanbit Nuclear Power Plant Units 3 and 4

Daegun Lim and Man Gyun Na*

Dept. of Nuclear Engineering, Chosun University, 309 Pilmun-daero, Dong-gu, Gwangju, Korea

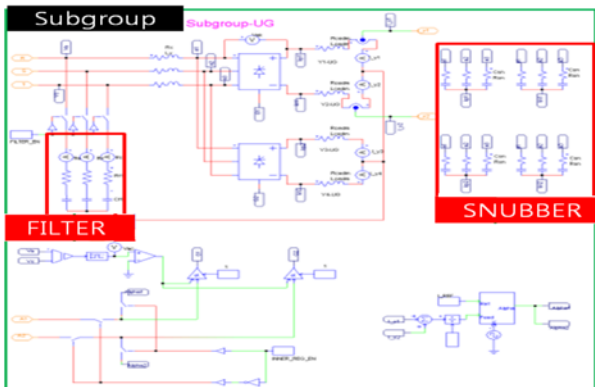
Fig. 4. Modeling with R-C filters and snubbers

The result of simulation tests is shown in Table 2. The THD was improved from 41.3% to 22.9% by installing the proposed R-C filter. The phase voltage V_{peak} value was also improved from 295.3V to 215.3V. Therefore, it was evaluated as a solution to fundamentally solve the failure of MG-set synchronization and UVR burnout which are potential risks

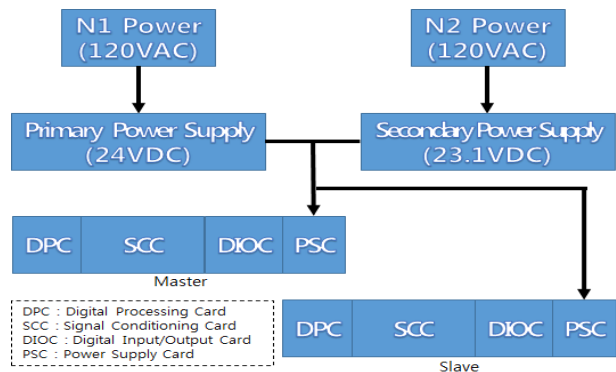
Fig. 5. Power circuit and filter

The CEDMCS has experienced a number of secondary power supply failures (11 times) that affect safe operation of the Hanbit NPP units 3 and 4. The power supplies of the CEDMCS are redundant and maintained under a hot & standby mode. So, the secondary power supplies are in no load condition during normal operation.

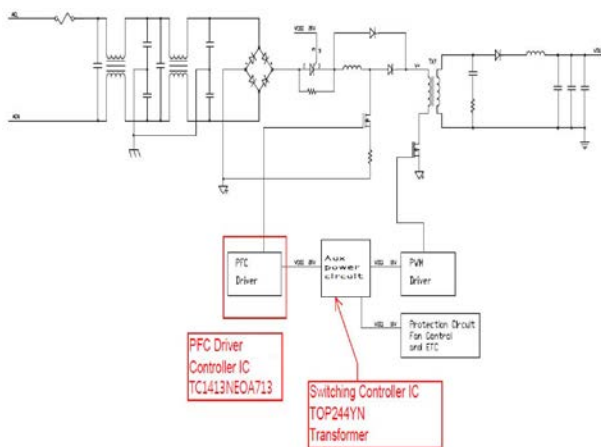
Fig. 7. Block diagram of power supply

The block diagram of the power supply circuit and the circuit diagram for the main fault section are shown in Fig. 7.
