Visual Inspection of the Flow Distribution Plates of Ulchin NPP #3 SG

Woo-tae Jeong^{a*}, Seok-tae Kim^a, Seok-chul Kang^b, Young-kug Kim^b

^aKorea Electric Power Research Institute, Nuclear Power Lab., 103-16 Munji-dong, Yusung-gu, Daejeon, Korea 305-380

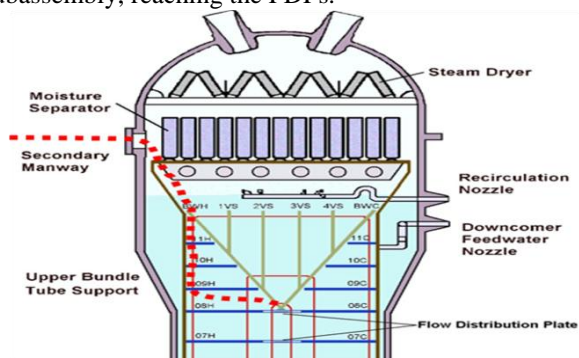
Fig.1 Flow Distribution Plates

Two FDPs were installed in central cavity area of Ulchin NPP #3 SG to prevent flow induced vibration (FIV) of SG tubes as shown in figure 1. We designed a visual inspection system to identify 16 bolts of each FDP. The positioning subassembly was designed to be attached on the secondary man-way to adjust the location of the probe guide subassembly^[2]. The probe guide subassembly is inserted through the secondary man-way, wrapper hole, and the gap between wrapper and SG tube bundle. Finally, a quartz video-probe is inserted through the holes in the positioning subassembly, reaching the FDPs.

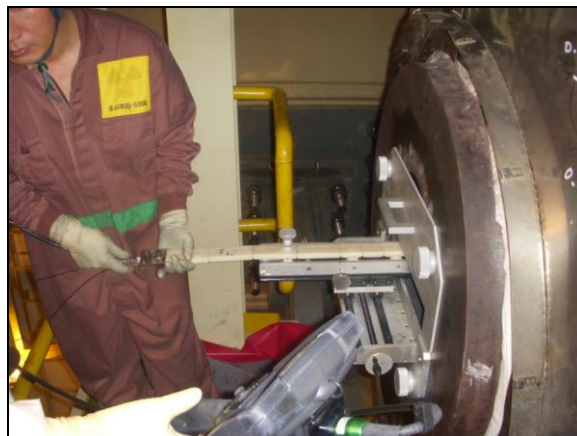
Fig.2 Visual Inspection System

Figure 2 shows the visual inspection system which was installed for the first time to the man-way flange of Ulchin #3 SG on 25th of February during outage period. Two men were involved in the installation and operation of the inspection system. A man adjusted the length, and another man adjusted the direction of the video probe.
