Assessment of a leakage by a water pressurization on a degraded SG tubes

Chan NamGung, SeongSik Hwang, Jangyul Park, ManKyo Jung, HongPyo Kim
Korea Atomic Energy Research Institute, 1045 Daedeokdaero, Yuseong, Daejeon, Korea 305-353

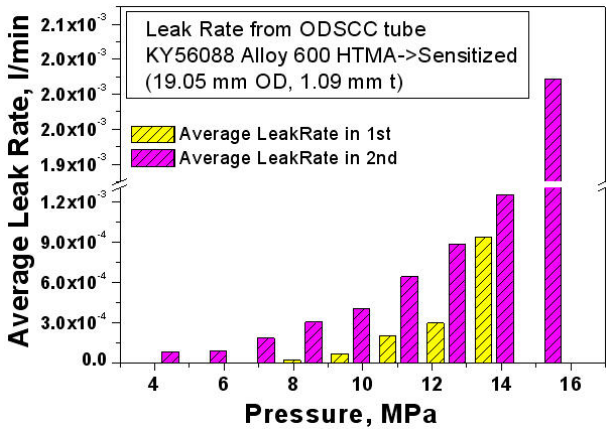
Fig.2. Typical leak behavior for a degraded SCC tube at room temperature.

Several SG tube specimens with various SCCs were tested for the present investigation. The SCC flaws have a characteristically different flow path through crack surface and a different leak behavior. Fig.2 shows the typical behavior of the pressure and leakage rate during water pressurization on a degraded SCC tube. In case of that specimen, the leak tests were conducted 2 times with the same specimen (KY56088). As the pressure increased, the crack opening area (COA) increased and the leak rate also increased consequently. Because the flow path and the crack width were deformed during the 1st test, the average leak rate in the 2nd test was greater than that of the 1st experiment.

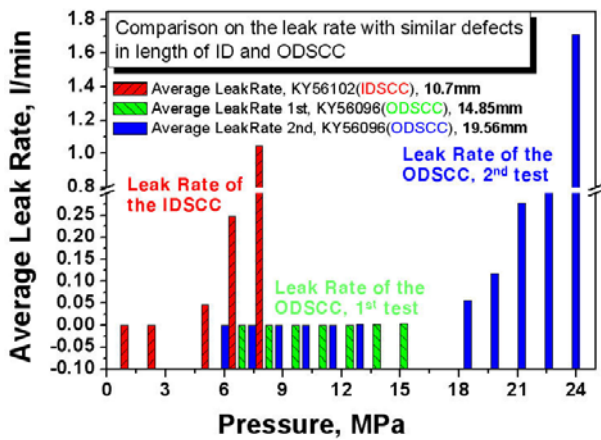
Fig.3. Comparison on the leak rate of the ID and ODSCC with similar crack length.

The behavior of the leakage measured and compared leak rates of the ID and ODSCC are shown in Fig.3. As already demonstrated in Fig.2, the leak rate of an ODSCC in the 2nd test was greater than that in the 1st. Despite the low water pressure region and the shorter length of IDSCC than that of ODSCC, the leak rate of the IDSCC was much larger than ODSCC one. This implies that ID side developed cracks are more easily opened than OD side initiated cracks.
