# A High Dose-Rate Gamma Irradiation Test of Passive Elements of Radiation-Tolerant Camera System

JaiWan Cho<sup>1</sup>, YoungSoo Choi<sup>1</sup>, and Jung Cheol Shin<sup>2</sup>  
<sup>1</sup>Korea Atomic Energy Research Institute, <sup>2</sup>Korea Nuclear Fuel.  
 E-mail: [jwcho@kaeri.re.kr](mailto:jwcho@kaeri.re.kr)

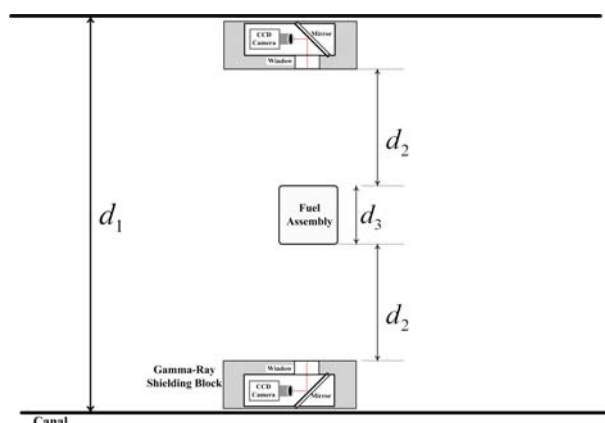
Fig. 1. A schematic diagram for the VT of fuel assembly

As shown in Fig. 1 and 2, the passive elements, mirror and visible window, which are placed in the optical path of CCD camera, are exposed to a high dose-rate gamma-ray source directly. So, the gamma-ray irradiation characteristics of passive elements, is needed to test. We have conducted high dose-rate (up to 264kGy) gamma irradiation experiments on a visible window materials and mirror.
