## Laboratory-Grown Axial Cracks in the Secondary Side of Steam Generator Tubes

Do Haeng Hur\*, Myung Sik Choi, Jung Ho Han, Deok Hyun Lee

Korea Atomic Energy Research Institute, 150 Deokjin-dong, Yuseong-gu, Daejeon, 305-353

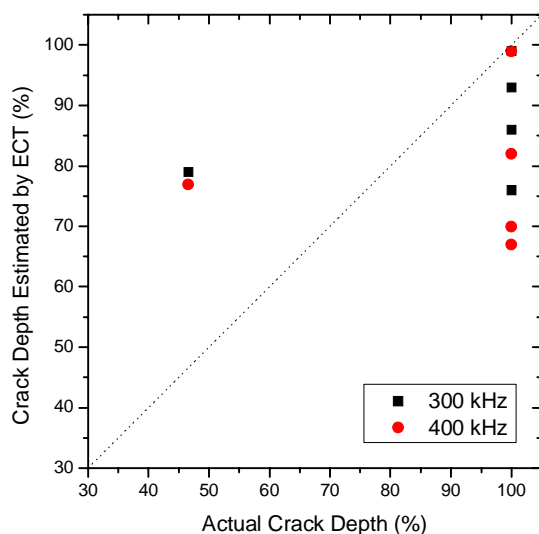
Figure 3. Crack depth correlation between the ECT results and destructive results.

Crack depth and length are the main parameters of sizing a crack using ECT. Crack depth was estimated based on the phase angle to flaw depth correlation of plus coil at frequencies of 300 kHz and 400 kHz. These results were directly compared with the destructive results. As shown in Figure 3, the crack depth estimation from the phase angle resulted in very low reliability, regardless of the test frequencies.
