The Cyclic Strain Rate Dependence on Environmentally Assisted Cracking Behaviors of SA508 Gr. 1a Low Alloy Steel in 310°C Deoxygenated Water

In this study, low cycle fatigue (LCF) tests were conducted to investigate the fatigue life of SA508 Gr. 1a LAS in 310°C deoxygenated water. Also, the fatigue surface and sectioned area were observed for evaluation of cyclic strain rate dependent EAC mechanism in high temperature water.

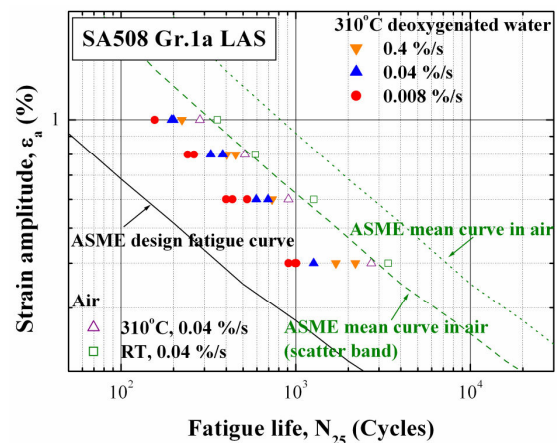
Figure 1 shows the fatigue life of SA508 Gr.1a LAS with various loading conditions in various environments. As shown in figure 1, under the same loading condition, the fatigue life in 310°C deoxygenated water was shorter than that in air. The fatigue life of SA508 Gr. 1a LAS in 310°C water reduced with a decreasing strain rate, from 0.4 to 0.008 %/s. As I mentioned previously, it is reported that the reduction in the fatigue life in 310°C water is related with the EAC mechanisms.

Figure 1. Fatigue life of SA508 Gr.1a LAS.
