## Failure Analysis of Zircaloy-4 Cladding after LOCA Thermal Shock

Jun Hwan Kim, Myoung Ho Lee, Byoung Kwon Choi, and Yong Hwan Jeong<sup>a</sup>  
*a Advanced Core Materials Lab., Korea Atomic Energy Research Institute, Daejeon, 305-353, Republic of Korea*  
junhkim@kaeri.re.kr

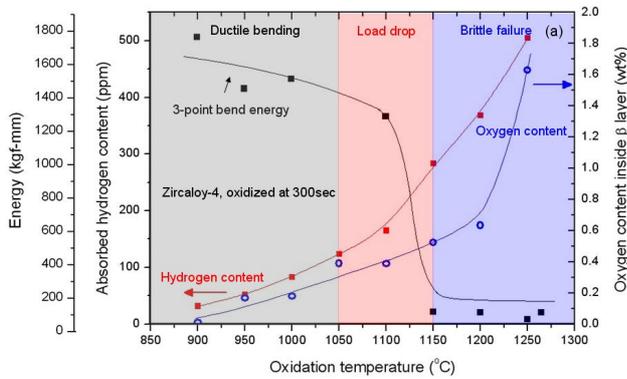
Figure 1. Changes of the material properties of the Zircaloy-4 cladding with the oxidation temperature.

Fig. 1 is the changes of the material parameters of the Zircaloy-4 cladding with the oxidation temperature. Ductile bending is shown when the cladding is oxidized at a relatively low temperature ('Ductile' region). Successive load drops caused by a fracture of the surface oxide appeared when the cladding was oxidized at the intermediate temperature region. ('Load drop' region) Finally, a brittle fracture which could not sustain the first load drop appeared when the cladding was oxidized at a high temperature. ('Brittle failure' region) Absorbed energy can be defined as the area under the load-displacement curve which has a dimension of the energy. Energies obtained by the 3-point bend tests decreased with the oxidation temperature, and they showed an abrupt decrease between 1100°C and 1150°C. Both the absorbed hydrogen content and the oxygen content inside the beta layer increased with the oxidation temperature. Absorbed hydrogen content gradually increased in all the temperature regions. When the absorbed hydrogen content exceeds around 270ppm, the Zircaloy-4 cladding showed a brittle fracture for the mechanical test. Oxygen content inside the beta layer increased smoothly up to 1150°C then it increased rapidly above this temperature. The oxygen content to cause a ductile bending of the cladding is below 0.3wt%. When the oxygen content inside the beta layer reaches between 0.3 and 0.5wt%, the Zircaloy-4

cladding begins to decrease in its energy and show a load drop caused by a decrease of the load bearing area as well as the embrittlement itself. Above 0.5%, the cladding cannot withstand the load, and it shows a nil ductility.

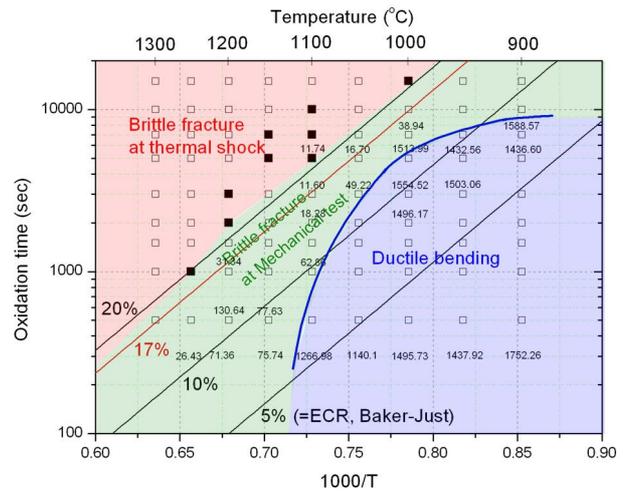
Figure 2. 3-point bend fracture energy diagram of the Zircaloy-4 cladding with the oxidation temperature and time.

Fig. 2 is the 2-dimensional failure map of the Zircaloy-4 cladding. Closed symbol represents the failed cladding during the water quench. ‘Ductile bending’ (blue region in Fig. 2) means that the cladding can maintain its mechanical ductility after a thermal shock, not to mention a survival during a water quenching. ‘Brittle fracture at the mechanical test’ (green region in Fig. 2) means that although the cladding at first survived the water quenching, it has already lost its mechanical ductility so that it could fail during a handling, such as refueling or transporting the fuel bundles to the spent fuel storage [2]. ‘Brittle failure at a thermal shock’ (red region in Fig. 1) indicates that the cladding is too brittle to withstand even a thermal stress during a water quenching. From the diagram, ‘Ductile bending’ region decreases with the oxidation temperature. For instance, a ductile bending occurs irrespective of the oxidation time when oxidized below 950°C. Oxidized cladding at 1000°C loses its mechanical ductility above 5000sec. Finally, oxidized cladding at 1150°C shows its mechanical ductility only at 300sec. This implies that the maximum ECR to withstand a ductile bending is around 15% when oxidized at 1000°C. It gradually decreases to have a ductility below 10% when oxidized above 1100°C.
