Effect of Manufacturing Process on Corrosion Characteristics of HANA-alloy

Hyun-Gil Kim^{a,*}, Byoung-Kwon Choi^a, Yong-Hawn Jeong^a, Kyu-Tae Kim^b

^a Zirconium Fuel Cladding Team, Korea Atomic Energy Research Institute, Daejeon 305-353, Korea

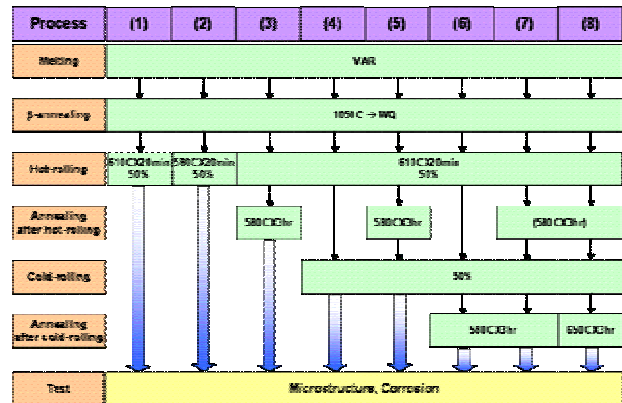
Fig. 1 Manufacturing process of HANA-alloy

The experimental HANA-alloy was manufactured by the sequence of the vacuum arc re-melting of 4 times to promote the homogeneity, β -quenching at 1050 °C, and hot and cold rolling. To study the manufacturing effect such as annealing temperature and hot and cold rolling effect, the β -quenched HANA-alloy was hot-rolled after pre-heating at 580 or 610 °C for 30 min and then applied the cold rolling steps of different times. The cold-rolled samples were intermediate-annealed at 580 or 610 °C for 3 hours and then some samples were final-annealed at 580 or 650 °C for 3 hours. Therefore, the sheet type HANA-alloy having different 8 conditions was manufactured shown as fig. 1.

Fig. 2 shows the optical microstructures of HANA-alloy with different manufacturing process. Their microstructural characteristics were largely changed by manufacturing process shown as fig. 1. The martensite structure (prior β phase) was formed at water quenched samples from β region of 1050 °C. The massive large grains were observed in the case of process (1), (2) and (3), and the elongated grains were observed in the case of process (4) and (5). The small recrystallized grains were observed in case of process (6), (7) and (8). From the these results of microstructure observation, homogenous microstructure such as small recrystallized grains was formed by the process of annealing after cold rolling.
