Monitoring Index of the Cameras during the High Dose-Rate Gamma Ray Irradiation

Jai Wan Cho and Kyung Min Jeong

Korea Atomic Energy Research Institute, (150-1 Dukjin-Dong), 1045 Daedeokdaero, Yuseong, Daejeon, Korea

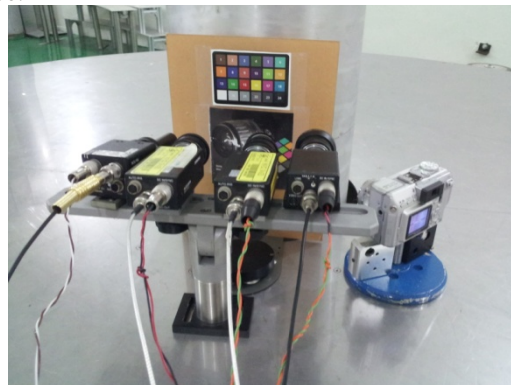
A typical experimental setup of gamma ray irradiation for the CCD cameras is shown in Fig. 1. The CCD cameras of various types were gamma irradiated at a dose rate of about 200 Gy/h until these cameras failed. And the distance between the target (CCD sensor) and the gamma ray source (Co-60) is 13.7cm.

As shown in Fig. 1, the CCD sensor takes a front view of the resolution target to the rear of the gamma ray source.

Fig. 1 Various CCD cameras take a front view of the gamma ray source (Co-60).

To evaluate the on-line performance of various cameras simultaneously, as shown in Fig. 1, a 4 channel video multiplexer is used. After about 43 minutes elapsed, two B/W CCD cameras (yellow sheet as stuck on the top of the camera body, as shown in Fig. 1) failed at a 143 Gy (TID) dose. The other two B/W CCD cameras survived after about a 74 minute irradiation dose (246 Gy TID). The manufacture year of the two failed CCD cameras is 1998. And the other two surviving CCD cameras were fabricated in 2001. A digital still camera (manufactured in 2004) positioned at the rightmost side of Fig. 1 also failed after the same dose (246 Gy TID).

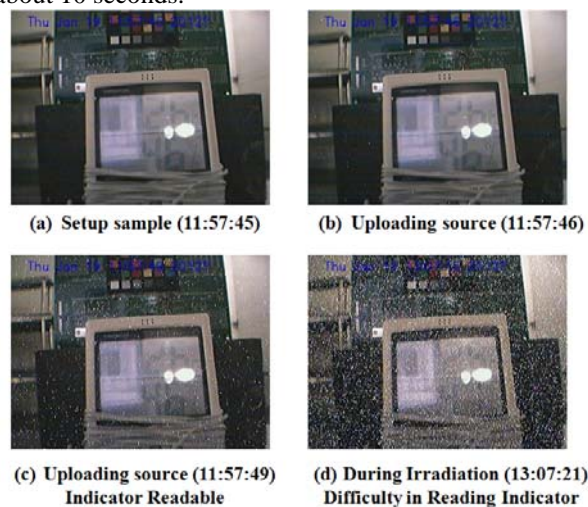
A monitoring index of a CMOS web camera as shown in Table 2 is 23.26 at a 18 Gy/h gamma ray dose rate. Figure 2 shows an LCD panel monitoring image of a thermo/hygrometer using a CMOS web camera under an 18 Gy/h gamma ray dose rate condition. Generally, the setup time of the gamma ray source from the

Fig. 2 LCD panel monitoring image of thermo/hygrometer using a WEB camera under gamma ray irradiation (18 Gy/h)

As shown in Fig. 2(d), when the monitoring index of the CMOS web camera is bigger than 20, it is not easy to read the LCD panel display number of the thermo/hygrometer. In the case of Fig. 2(b) and Fig. 2(c), the numbers of speckles are 136 and 3199, respectively, and the monitoring index is 0.18 and 4.17. Therefore, it is legible to easily read the LCD panel display digit of the same instrument because the gamma ray dose rate is low during the setup time of the gamma ray source.
