Oxidation Behavior of Fe-based Alloy under Normal Operation and Accident Conditions

Dong Jun Park, Jung Hwan Park, Yang Il Jung, Hyun Gil Kim, Jeong Yong Park, and Yang Hyun Koo
LWR fuel Technology Division, Korea Atomic Energy Research Institute, 989-111 Daedeok-daero,
Yuseong-gu, Daejeon 305-353, Korea
*Corresponding author: pdj@kaeri.re.kr

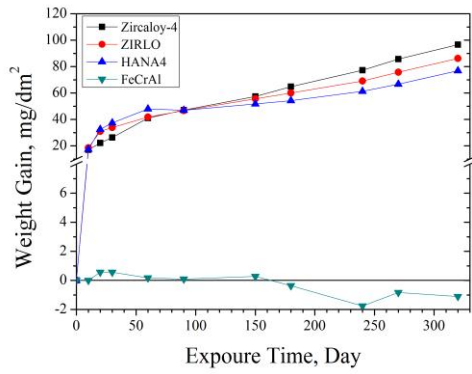
Fig. 1. Corrosion behavior of the FeCrAl alloy in 360C water.

To compare the corrosion behavior of FeCrAl alloy and existing Zr-based alloys, their weight gain obtained from water static autoclave tests is presented in Fig. 1. FeCrAl alloy showed extremely low weight gain compared to Zr-based alloys. Weight gain of FeCrAl specimens up to 150 days test was less than 1 mg/dm². On the contrary, Zr based alloys showed almost 100 1 mg/dm² in their weight gain. The oxide scale formed on the surface of FeCrAl sheet sample during corrosion test was analyzed by TEM and EDS measurement and shown in Fig. 2. For microstructural characterization, additional XRD analysis was carried out. The morphology of oxide layer was uneven and its thickness was not more than 500 nm. EDS and XRD analysis indicates that Fe₂O₃ was formed during 360°C test.

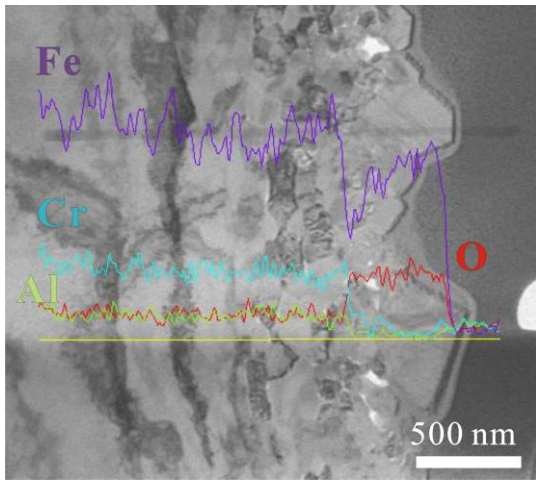
Fig. 2. Cross-sectional TEM image and EDS measurement from alloy matrix to oxide layer.

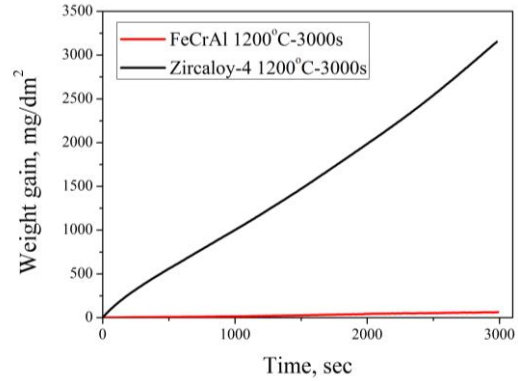
Fig. 4. Weight gain of FeCrAl and Zr alloys during high temperature oxidation test with TGA.

To investigate oxidation resistance of FeCrAl alloy, high temperature oxidation tests were carried out under steam environment. Fig. 4 shows the weight gain behavior of FeCrAl alloy oxidized at 1200°C for up to 3000s. FeCrAl showed only 60 in their weight gain

after exposure time of 3000s. It is just 1.8 % compared with that of Zircaloy-4 sample. Oxide formed during high temperature oxidation test was analyzed by XRD measurement. Fig. 5 shows the result. It was revealed that grown oxides is alumina layer. This result is not consistent with that obtained from 360°C test.
