Seismic Capacity Estimation of Steel Piping Elbow Under Low-cycle Fatigue Loading

Seismic Simulation Test Center
Institute for Research and Industry Cooperation at
Pusan National University.
Mulgeum, Yangsan, Kyungsangnam, South Korea

한국원자력연구원
Korea Atomic Energy Research Institute

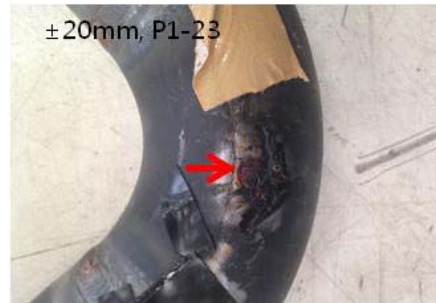
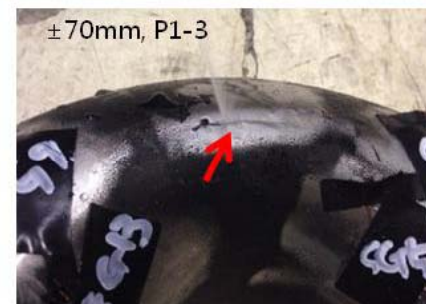
Test results of 3 in. elbow specimen component

Leakage Nth cycle of elbow specimen

- 1) $\pm 20\text{mm}$: 82, 108, 110, 87, 76, 98
- 2) $\pm 30\text{mm}$: 45, 46, 29, 29, 38
- 2) $\pm 40\text{mm}$: 17, 18, 18, 14, 15
- 3) $\pm 50\text{mm}$: 11, 10, 11, 9, 12
- 4) $\pm 60\text{mm}$: 6, 6, 8, 8, 8, 8
- 5) $\pm 70\text{mm}$: 4, 5, 5, 4, 6
- 6) $\pm 80\text{mm}$: 5, 4, 4, 5, 4, 4, 5
- 7) $\pm 90\text{mm}$: 4, 4, 4, 4, 4
- 8) $\pm 100\text{mm}$: 4, 3, 4, 4, 3

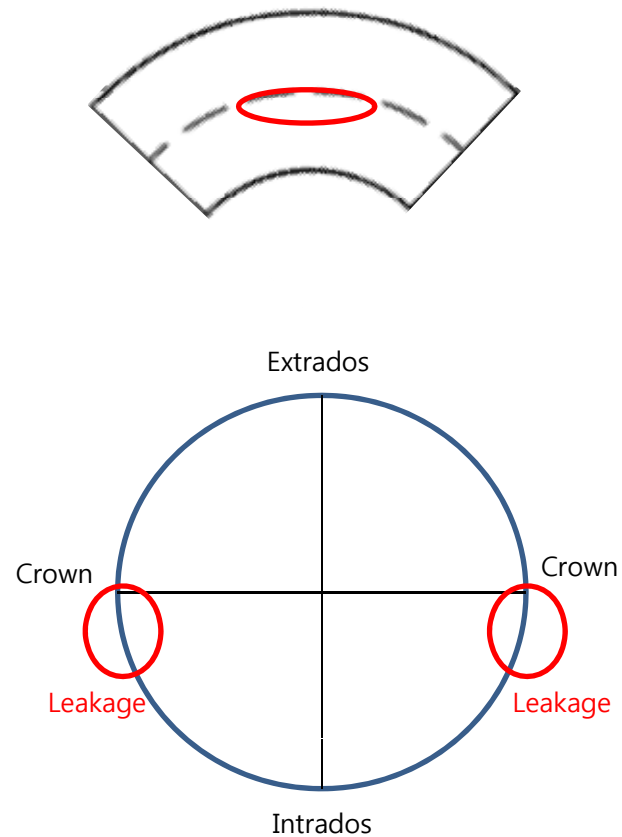
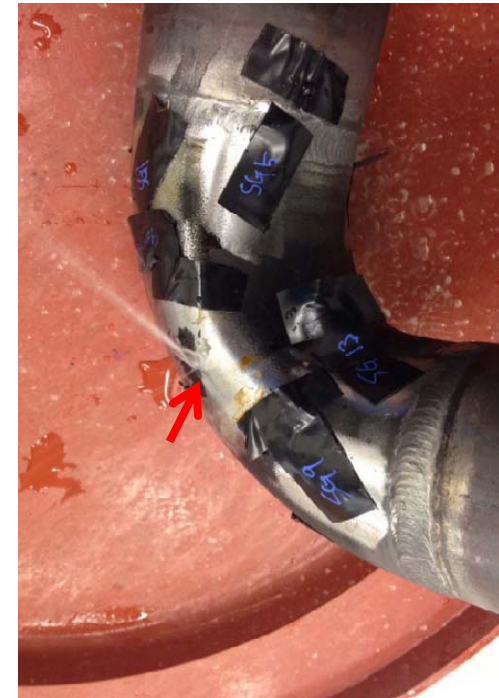
Leakage Point of Elbow Specimen

- Leakage occurred on the near the crown in intrados direction
- Cracks (ruptures) grew up in axial direction

Leakage phenomenon occurred on and near the crown in piping elbow. Those cracks grew up in axial direction.

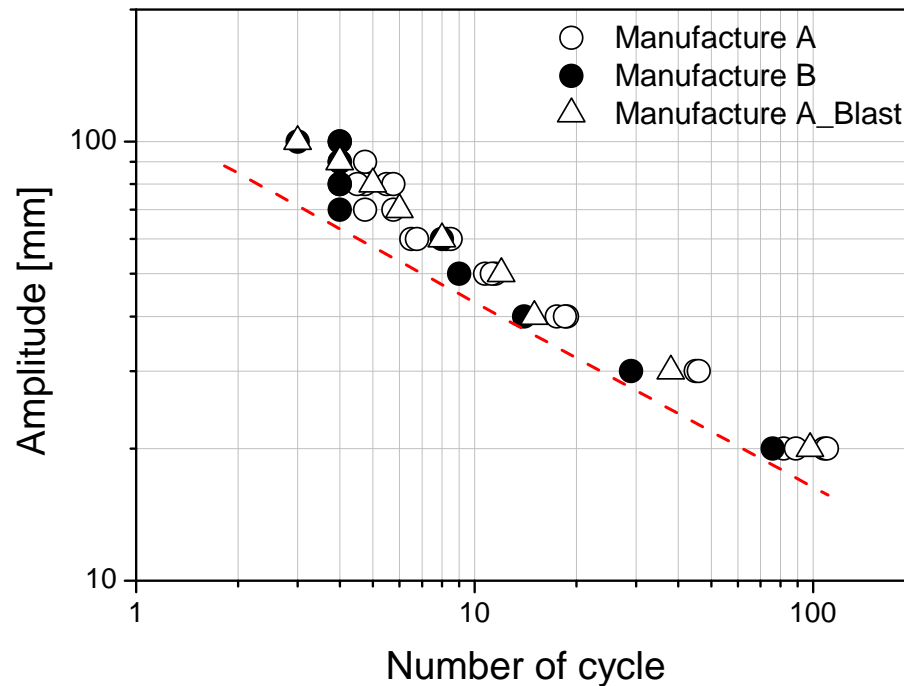
Fatigue curve

Fatigue Curve for 3in. SCH40 Steel Pipe Elbow

- Loading amplitude exponentially decreased as the number of cycles increased
- Use maximum loading amplitude
- Exponential function
- Similar to other research results

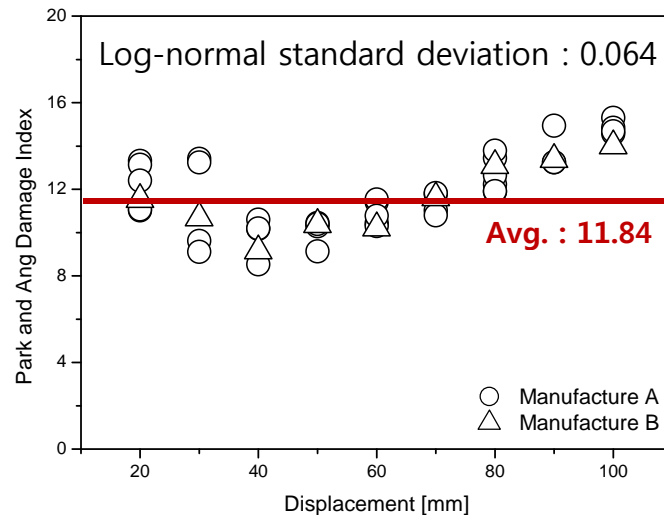
- Park and Ang, (1985)

$$D = \max\left(\frac{D_i}{D_y}\right) + b \sum_{i=1}^N \left(\frac{E_i}{F_y D_y}\right)$$

Park and Ang : $d=0.025$

Failure criteria of the piping elbow considering the dissipated energy.

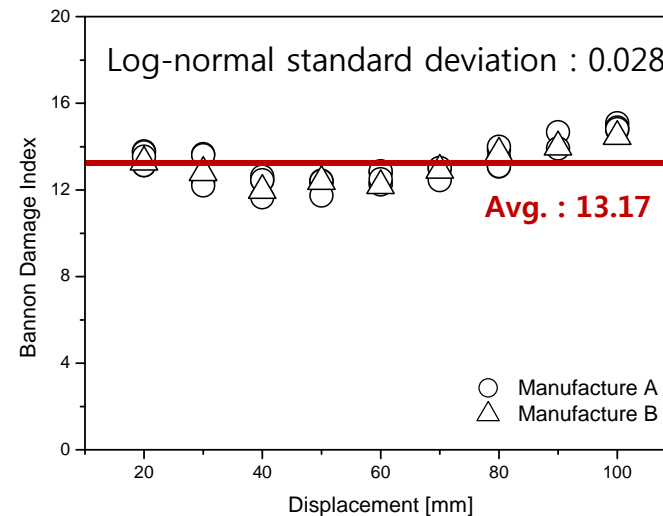
- Banon (1981)

$$D = \sqrt{\left(\max\left(\frac{D_i}{D_y} - 1\right)\right)^2 + \left(\sum_{i=1}^N c \left(2 \frac{E_i}{F_y D_y}\right)^d\right)^2}$$

Banon: $c=3.3, d=0.21$
