Diagnosis of PWSCC-induced Burst and Leak Processes in U-bend Regions of Steam Generator Tubes Using Acoustic Emission Method

Kaige Wu, Myung Sik Choi, Deok Hyun Lee *

Korea Atomic Energy Research Institute, 989-111 Daedeok-daero, Yuseong-gu, Daejeon, 34057, Republic of Korea

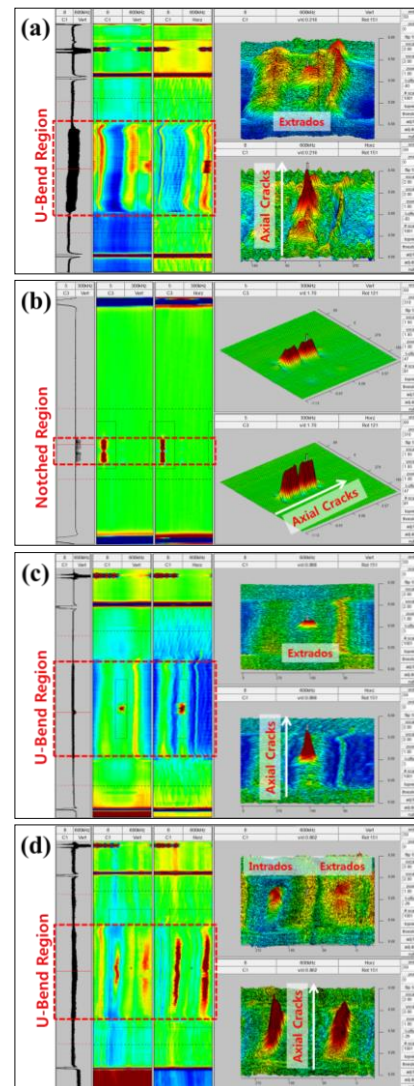
Fig. 1 shows the ECT signals in C-scan graphs from different tube samples. Here, samples #a, #c and #d are U-bend tubes which were previously exposed to sodium tetrathionate and sample #b is a straight tube with EDM notched crack. It is clearly observed that the great ridges along the axial direction are distinguished from the

Fig. 1. C-scan graphs of plus point coil signals from the tube samples #a, #b, #c, and #d.

background noise signals. These results confirm the existence of pre-made axial cracks inside the tube samples.

In the leak failure of sample #d, AE energy feature before leak failure was dispersive and high up to 10^5 aJ (Fig. 4d-2), suggesting that the formation and coalescence of void may occur simultaneously. Since the natural crack was deep enough and the wall to penetrate was thin (Fig. 1d), the linking between micro- and macro-voids is supposed to interpret the final leak failure. Here, it is worth noting that, AE signals after the leak failure, i.e., leak-AEs, are three orders of magnitude lower than the case of sample #c (Fig. 4c-2). This may be interpreted as follows: since failure pressure was very low (87bar, Table I), leak rate was accordingly lower, which is contributed to the relatively low-energy leak-AEs.

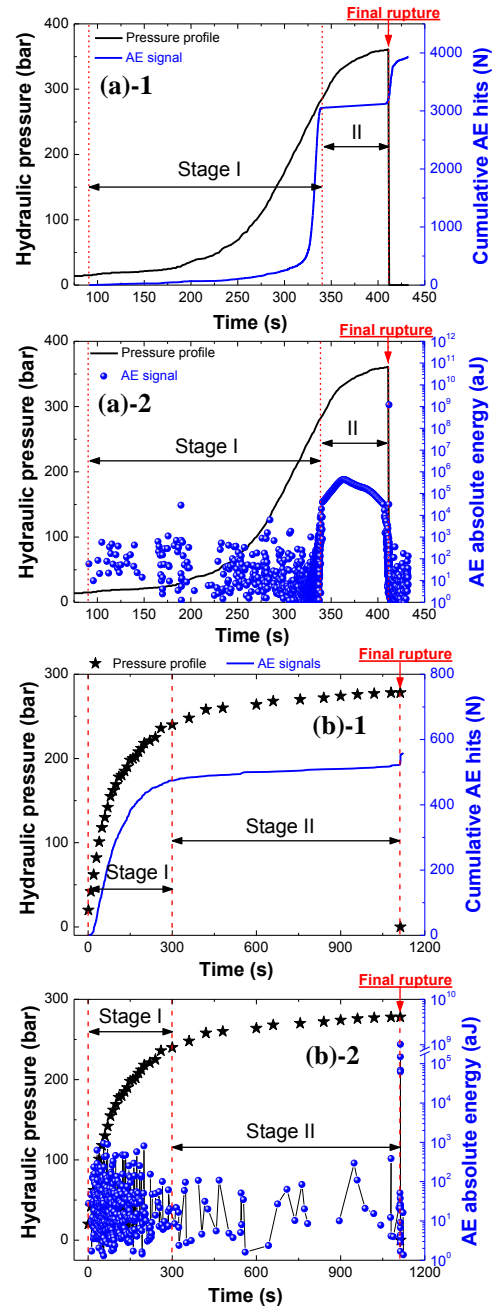
Fig. 3a and 3b show the AE results during tube burst process in samples #a and #b. Based on AE hits evolutions in Fig. 3a-1 and 3b-1, it clearly shows two stages. In stage I, AE activity was very active and hits number almost increased to a maximum by the end of Stage I. Once Stage II initiated, AE activity decreased but was still detectable. Finally, AE was activated again upon the burst rupture. From the AE energy evolutions in Fig. 3a-2 and 3b-2, AE signals in both stages I, mainly lower than 10^3 aJ, may be produced by plastic deformation around the crack tip. While the distinct features between samples #a and #b in AE stage II may be attributed to the different manufacture history. In stage II of sample #a, which had experienced work hardening during U-bent process, the energy loop with a

Fig. 3. AE results of hits and energy detected during the pressurization test for tube burst process: (a) 1-2: sample #a; (b) 1-2: sample #b.

peak around 10^6 aJ might be associated with the formation and coalescence of micro-voids. Upon the final rupture, ductile tearing of the ligaments between cracks may be responsible for the AE with high energy up to 10^9 aJ.

As for the case of notched straight tube sample #b, AE during the failure process may be interpreted by comparison with a tensile deformation of a pre-notched 304 stainless steel specimen [4]. Around the yielding, massive mobile dislocation during plastic deformation produced intense AE in stage I. But as strain increased, increasing of dislocation density can restrict the moving dislocation and thus glide distance for moving dislocations decreases, which may interpret the rare AE

in stage II. Approaching the final rupture, micro-void formation with the immediate coalescence may account for the high-energy AE signals (10^5 - 10^9 aJ).
