A Few Thoughts for Multi-unit Probabilistic Risk Assessment

KINGS

임학규 (hklim@kings.ac.kr)

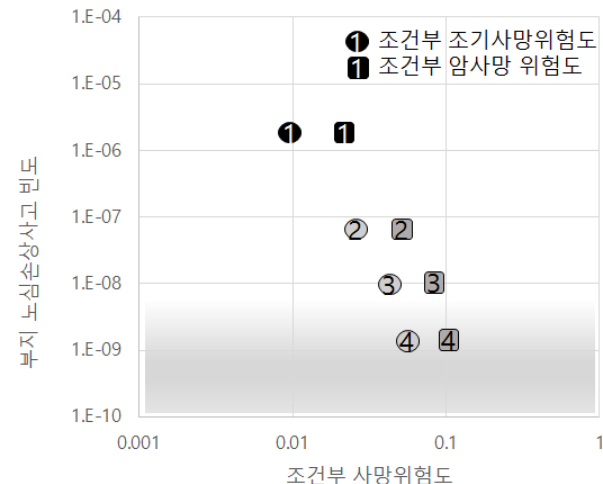
- 일부 국가에서 정량적 사회적 리스크 기준 설정
 - 국내 상황에는 부적절
- 다수기 리스크에 대한 관리기준 논의
 - 조건부 지표
 - 다수기 사망위험도 ÷ 다수기 노심손상사고빈도
 - 미국 NRC의 격납건물 성능목표 개념과 유사

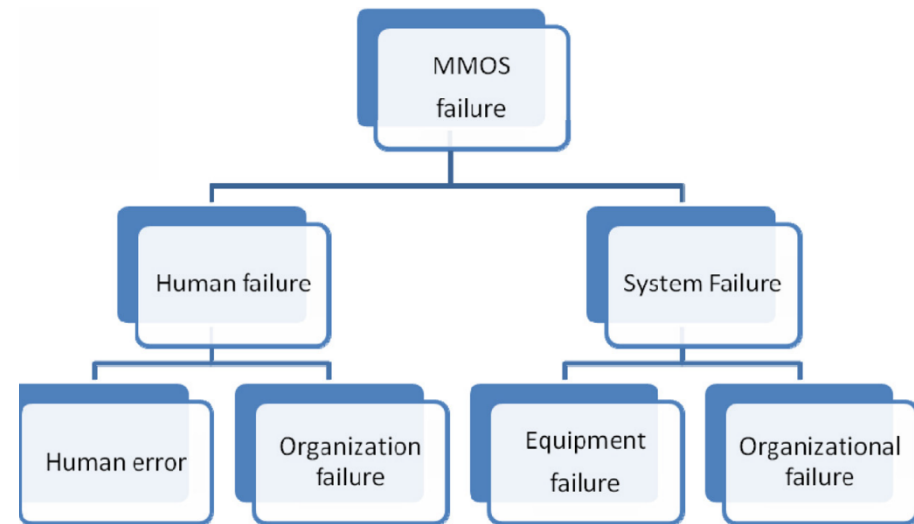
- 인간-기계-조직 시스템(MMOS) 모델
 - The organizational factor in PSA framework (Farcasiu et al., NED, 2015)

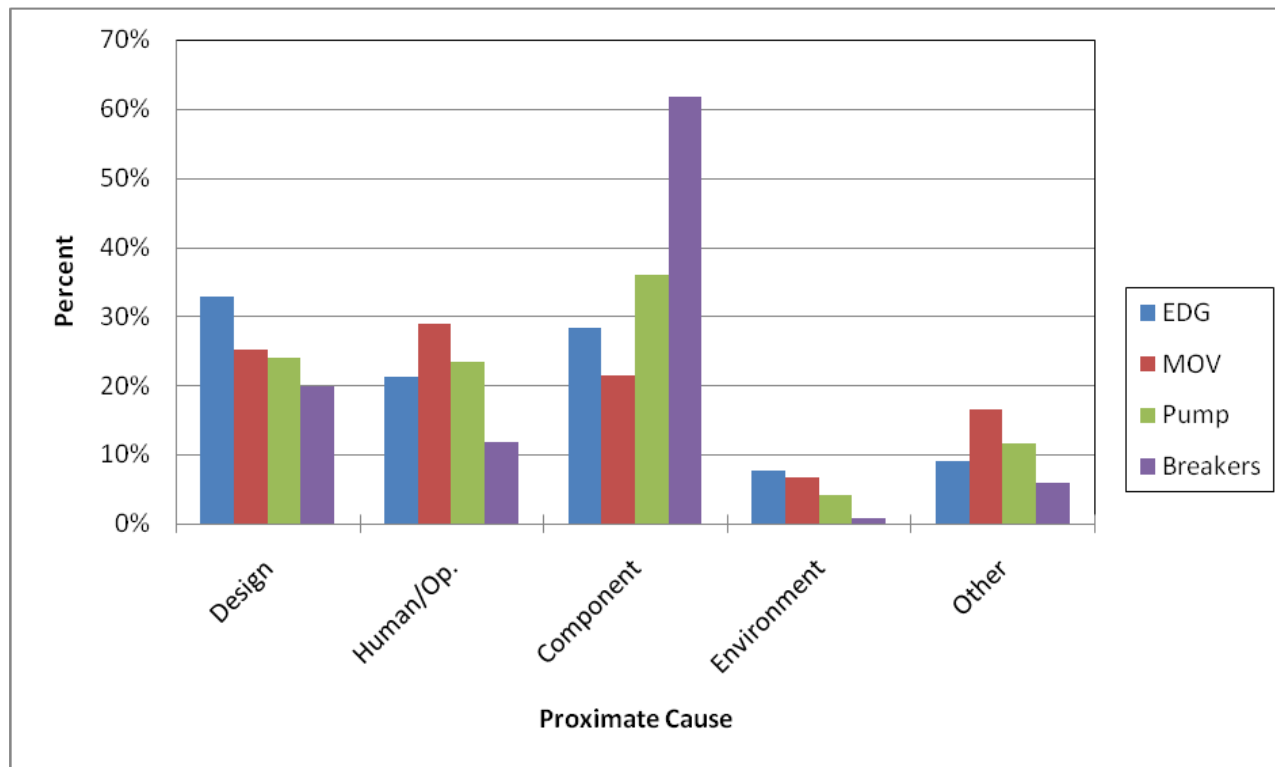
Figure 3. Proximate cause distributions for the four components

PSA2008, Rasmuson, et al. "SOME COMPONENT INSIGHTS FROM ANALYZING NRC'S COMMON-CAUSE FAILURE DATABASE"
