Establishing and Testing an Integrated LOCA Experiment Setup

Chan Lee*, Ashwini Kumar Yadav, Chang Hwan Shin, Kyung-Doo Kim

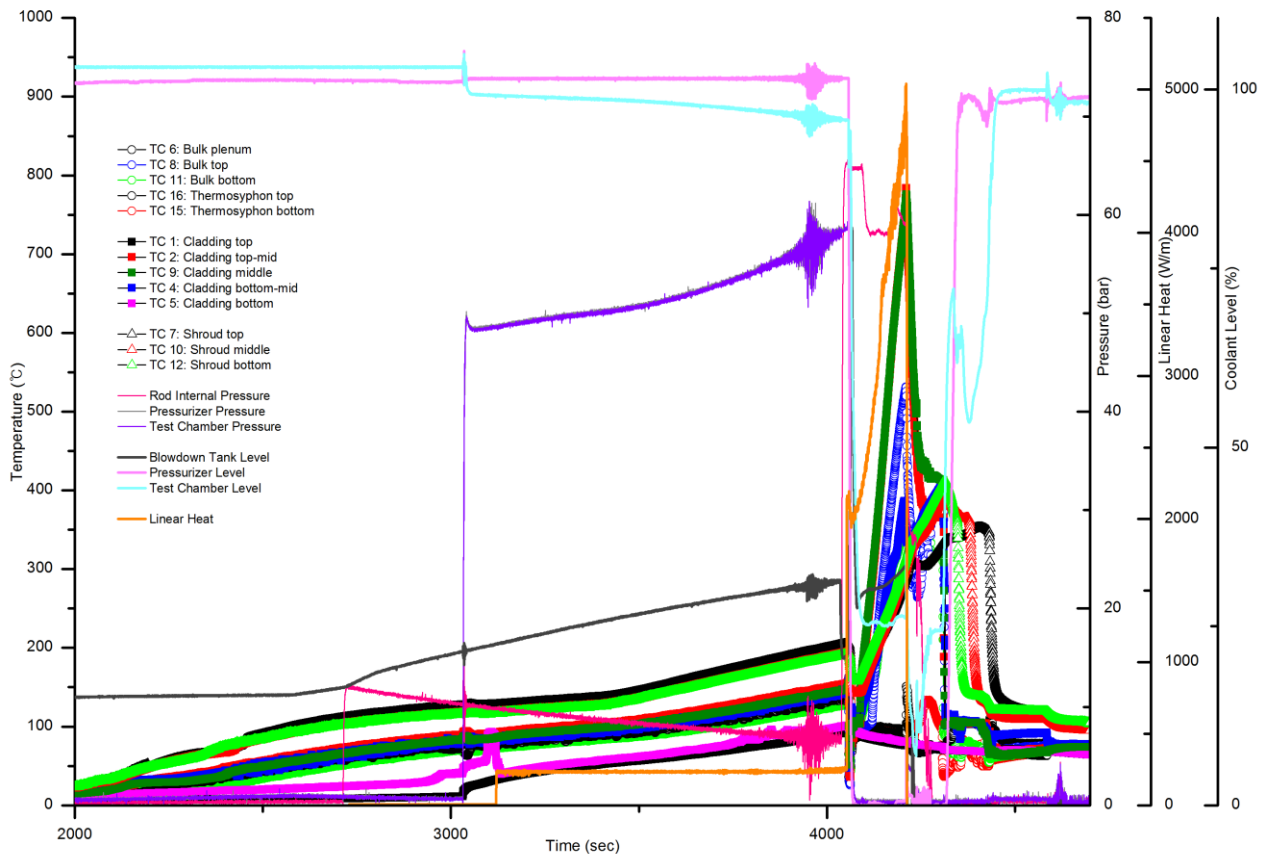
Fig. 2. Overall experimental data expressed in one figure. The chamber was pressurized at ~3000 sec and blowdown was initiated at ~4000 sec. Cladding was burst open at ~4200 sec and then cooled down by coolant reflooding.

The test chamber was fully filled with saturated water and fuel rod was quenched into ~100 °C within 5 minutes and the test was complete. Result of the test run is shown in Fig.2.
