Oxidation Behavior around PWSCC Crack Tips of Alloy 600

Yun Soo Lim*, Sung Sik Hwang, Hong Pyo Kim
Nuclear Materials Development Division, Korea Atomic Energy Research Institute
1045 Daeduk-daero, Yuseong, Daejeon, 305-353, Korea
*Corresponding author: yslim@kaeri.re.kr

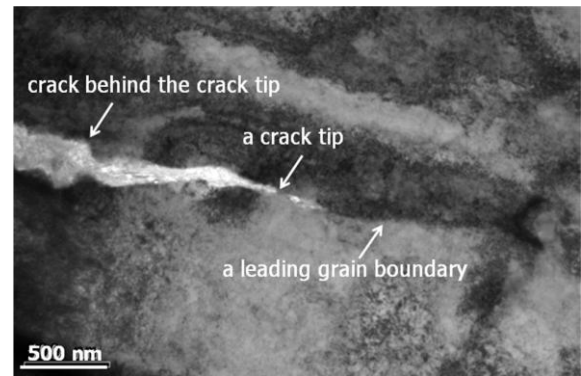
Fig. 2 TEM bright field image showing the morphology around a PWSCC crack tip

After the PWSCC test, the cracked CT specimen was used for the OM, SEM/EBSD and TEM/EDS examinations in the plane section. From the results, it was found that the cracks propagated along the random high angle grain boundaries, which had misorientation angles of over 15 degrees between the adjacent grains without any coincidence site lattice (CSL) speciality. It is well known that the random high angle grain boundaries have a higher energy than the low angle and/or CSL special grain boundaries. A TEM image showing the morphology around a crack tip is shown in Fig. 2. The region around a crack tip can be divided into three parts, that is, the crack behind the crack tip, the crack tip itself, and the leading grain boundary ahead of the crack tip. The important results from each part will be briefly described in the next section.

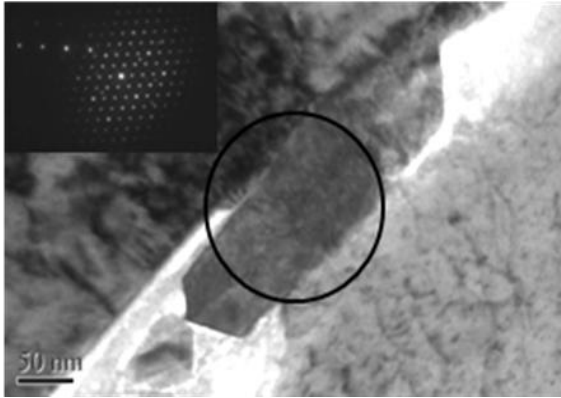
Fig. 3 TEM bright field image and diffraction pattern taken inside a crack

A bright field image and its related diffraction pattern taken from inside the crack behind the crack tip are provided in Fig. 3. A double layer was formed inside the crack, that is, inner and outer layers during PWSCC. The inner layer, which was adjacent to the matrix, was made of Cr oxides. The outer layer consisted of amorphous what with high O content, needle-type NiO, and faceted (Al,Cr,Fe,Ni) spinels. Moreover, a Ni-rich metal layer (no oxygen and Cr/Fe depletion) existed in the matrix adjacent to the crack wall.

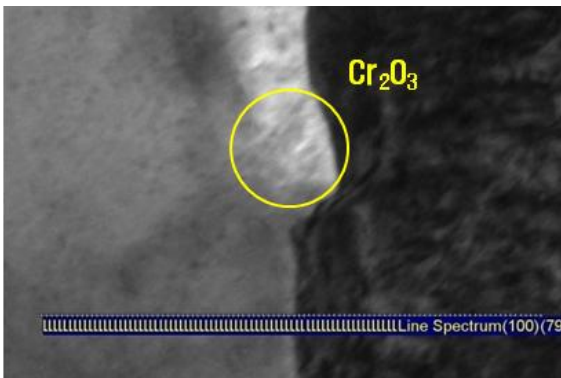
Fig. 4 TEM bright field image taken at the crack tip.

The bright field image taken at the crack tip is shown in Fig. 4. Contrary to the inside of the crack behind the crack tip, only Cr oxides, which were identified as Cr_2O_3 from the chemical composition analysis of the oxides, were found at the crack tip. Cr was depleted on the grain boundary ahead of the crack tip. Since Cr depletion did not occur at the grain boundaries before the PWSCC test, it might be due to the grain boundary diffusion of Cr ions during the Cr oxide formation.

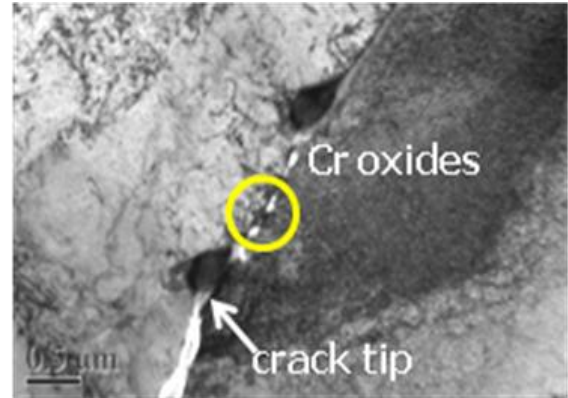
Fig. 5 TEM bright field image taken on the leading grain boundary ahead of the crack tip.

Some discrete Cr oxides were found on the leading grain boundary ahead of the crack tip, as shown in Fig. 5. Ni enrichment (or Cr/Fe depletion) at one side of the matrix, similar with the inside of the crack wall behind the crack tip, occurred at this boundary. Tiny oxides, which were several hundred nano-meters long and are possibly Cr oxides, were found on some leading grain boundaries. Oxygen was detected at the leading grain boundary, and the distance that oxygen diffused along the grain boundary from the crack tip was measured as ~ 700 nm. Most of the phenomena around the crack tips found in the present study agreed well with other's recent results [4-6].
