On-Line High Dose-Rate Gamma Ray Irradiation Test of the CCD/CMOS Cameras

Jai Wan Cho and Kyung Min Jeong

Korea Atomic Energy Research Institute, (150-1 Dukjin-Dong), 1045 Daedeokdaero, Yuseong, Daejeon, Korea

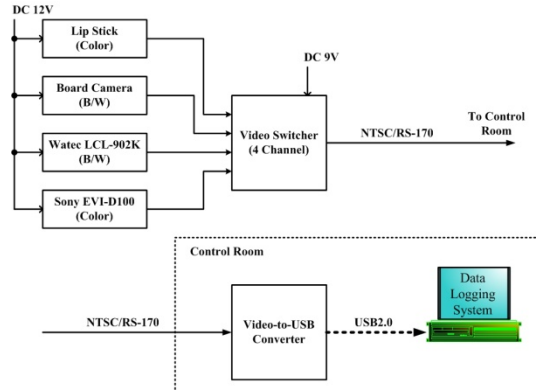
Fig. 1. A schematic diagram of the gamma irradiation test

A block diagram of a typical gamma irradiation set ups for the CCD/CMOS cameras are shown in Fig. 1 and Fig. 2.

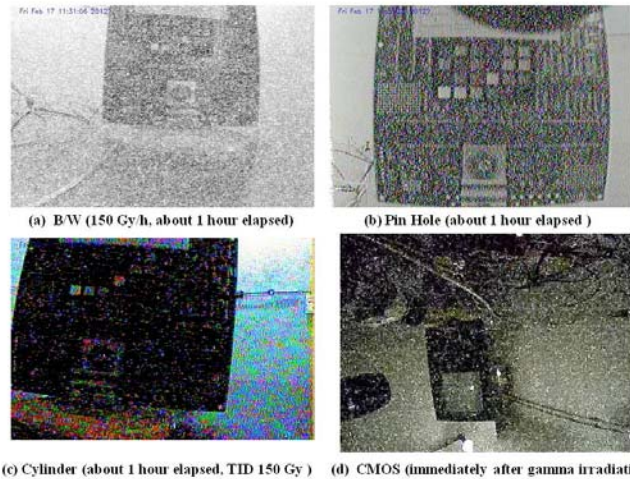
Fig. 4. Images of CCD/CMOS cameras during gamma ray irradiation (150 Gy/h doserate)

Fig. 4 shows gamma ray irradiation results of the CCD/CMOS cameras. The low-cost color CCD/CMOS cameras lose the color rendering function under high dose gamma ray irradiation (150 Gy/h, similar dose rate at the time of hydrogen explosion of Fukushima Dai-ichi nuclear power plant) as shown in Fig. 4. Fig. 5 shows gamma ray irradiation results of the high performance CCD camera (Sony EVI-D100, pan/tilt/zoom integrated module) under the same dose rate as the low-cost CCD/CMOS cameras. From the above experimental results, heavily generated speckles due to the high dose-rate gamma ray irradiation disturb detailed

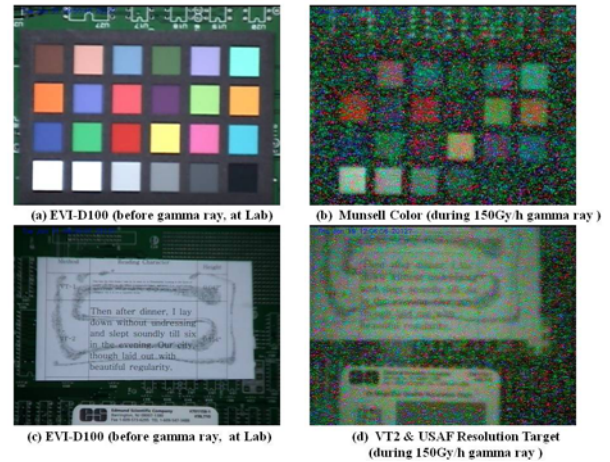
Fig. 5. Images of high performance CCD camera before and during gamma ray irradiation (150 Gy/h dose rate)
