Corrosion Behavior of Borated Stainless Steel in High DO-Borated Water Environment

Daehyeon Park ^{a*}, Yunju Lee ^a, Junhyuk Ham ^a, Seung Chang Yoo ^a, Kiyoung Kim ^b, Donghee Lee ^b and Ji Hyun Kim ^{a†}

^a Department of Nuclear Engineering, Ulsan National Institute of Science and Technology (UNIST), 50, UNIST-gil, Ulsan 44919, Republic of Korea

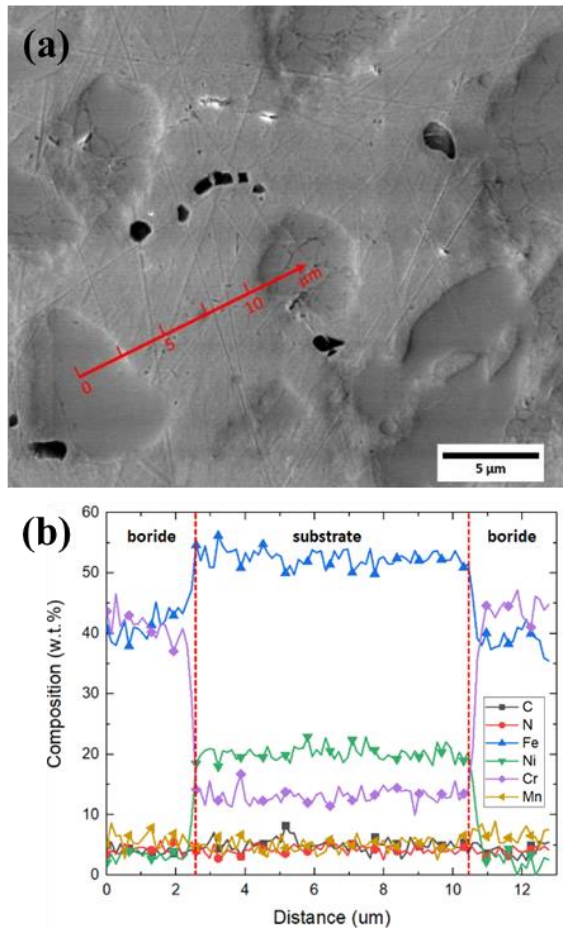
Fig. 1. (a) Secondary electron image of surface of specimen and (b) line EDS results of As-received specimen

Figure 1 (a) shows secondary electron image of surface of as-received specimen. Two phases of substrate and metallic borides were observed throughout the specimen. Since boride has higher hardness than substrate, substrate was grounded more than boride. Red arrow indicates the area where line EDS analysis was conducted which is presented in figure 1 (b).

Secondary phase is found to be metallic boride, $(FeCr)_2B$, which is assumed to be formed during production process because of the low solubility of boron in austenitic stainless steel. The composition of substrate was similar to SS304, however, it has lower Cr content and higher Ni contents than SS304.

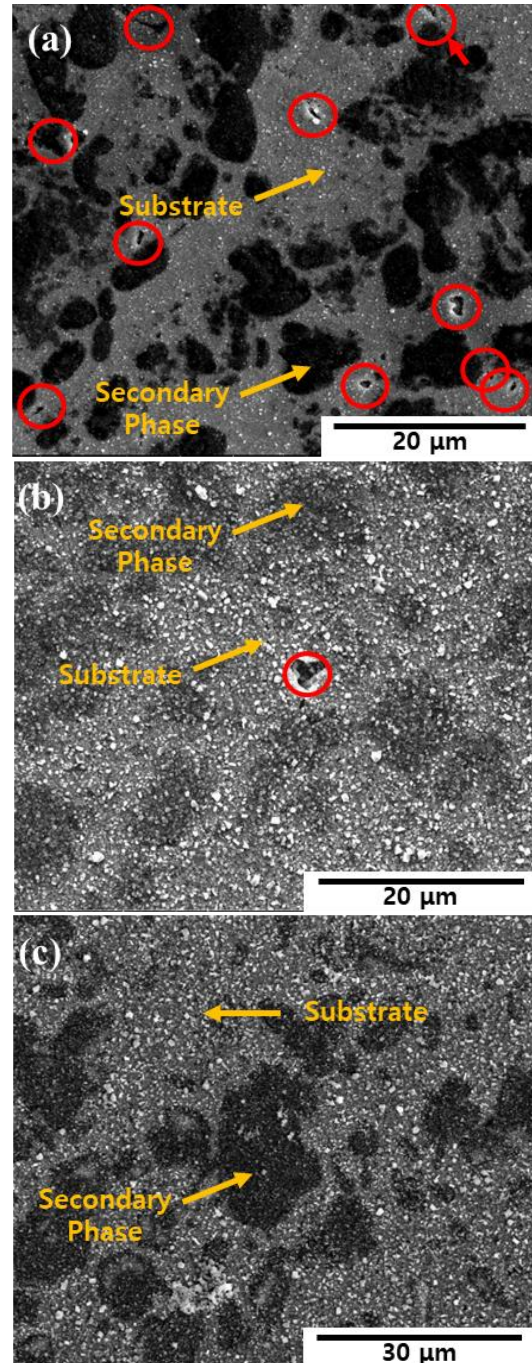
Fig. 2. Secondary electron images of specimen surface after (a) 0.2 months, (b) 2 months and (c) 4 months of accelerated corrosion experiment. Red circle indicates pitting corrosion observed.

Figure 2 shows secondary electron image of oxidized specimens. As the exposure time increased, pitting corrosion and oxide film was developed on overall

surface of BSS. BSS known to undergoes pitting corrosion in corrosive environment, and it was observed also in this study as marked with red circle in figure 2, mostly on substrate surface. Pitting corrosion was numerous observed in specimen which was exposed shorter time. However, the number of it was reduced with increased exposure time due to growth of oxide film on the surface.

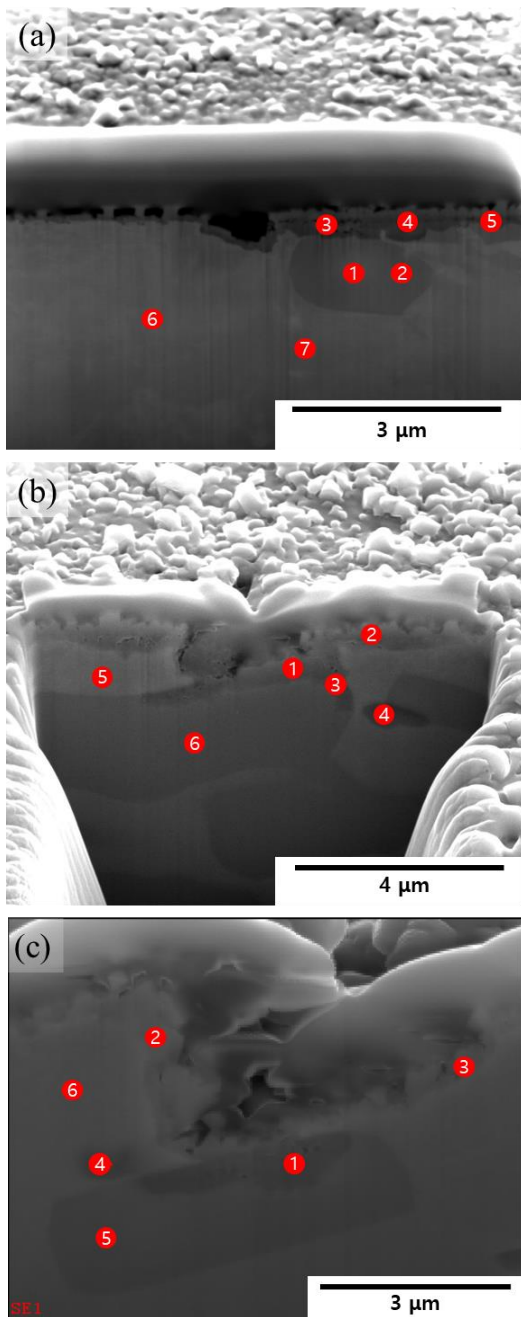
Fig. 3. SEM images of cross section of specimens after (a) 0.2 months, (b) 2 months and (c) 4 months of accelerated corrosion experiment. Red circle indicates where EDS point analysis was conducted.

Figure 3 shows SEM images of cross section of specimens after accelerated corrosion experiment. Those images were taken at the place where pitting corrosion observed. As shown in the figures, after pitting corrosion occurs in early stage of oxidation, the oxide film grew. Also, the secondary phase which was exposed to water was oxidized. Figure 4 shows thickness of oxide observed after accelerated corrosion experiment. Thickness of oxide film was depending on the exposure time. It can be observed that the thickness of the oxide film increases as the exposure time increases.

Table II: Point EDS results of 0.2 months exposed specimen presented in figure 3 (a)

Table III: Point EDS results of 2 months exposed specimen presented in figure 3 (b)

Table IV: Point EDS results of 4 months exposed specimen presented in figure 3 (c)

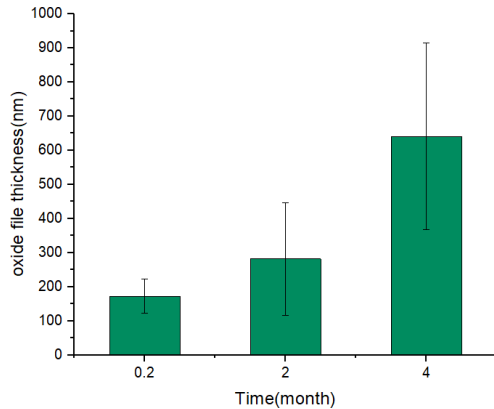
Fig. 4. Oxide film thickness of BSS specimens after accelerated corrosion experiment.

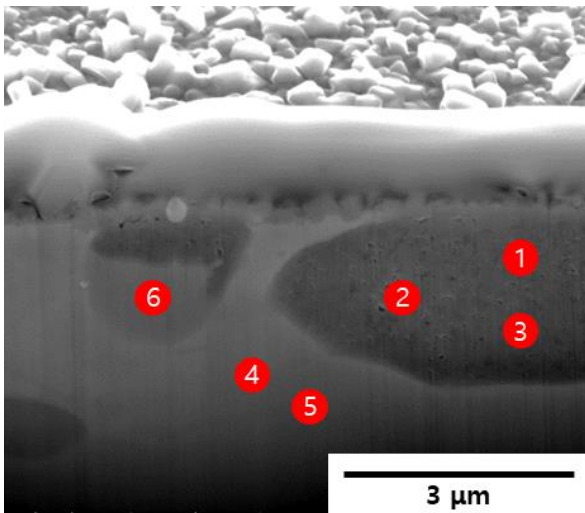
Fig. 5. SEM image of cross section of specimen after 4 months of accelerated corrosion experiment. Red circle indicates where EDS point analysis was conducted.

Figure 5 shows cross section of specimen after 4 months of accelerated corrosion experiment. As shown in the figure, secondary phase exposed to water was oxidized. From EDS analysis result shown in figure 5 and table V, darker area observed in figure 5 is oxidized particle which have higher oxygen concentration. And Cr contents were decreased compared to the non-oxidized secondary phase. Oxidized particle observed in 4 months of accelerated corrosion experiment shows porous oxide media. The secondary phase particles in 0.2 and 2 months exposed specimen also have porous oxide which contains relatively lower chromium elements and higher oxygen elements.

Table V: Point EDS results of 4 months exposed specimen presented in figure 4.
