Corrosion Performance of Coating for Venturi Fouling Mitigation at Nuclear Power Plant

*KNS 2021 Spring
Friday 14th May 2021*

Wonjun Choi and Chi Bum Bahn*
(Pusan National Univ.)

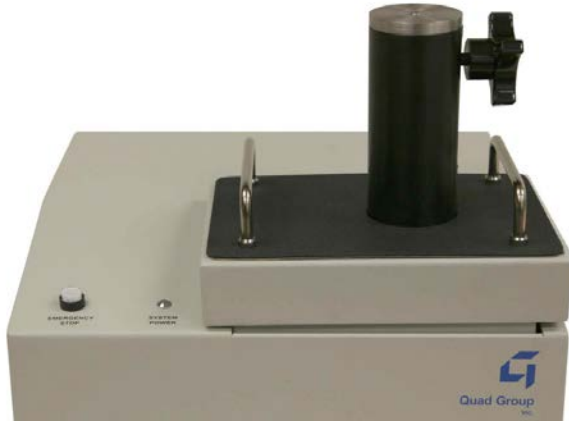
<Adhesion Test>

Pull-Down Breaking Adhesion Test
(ROMULUS system)

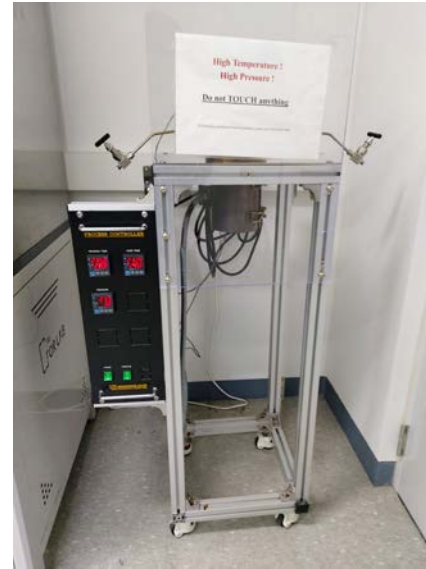
<Static Corrosion Test>

Temperature : 235 °C (포화증기압:400psig) *300hrs*
Waterchemistry Condition : pH 9.3, (ETA, N₂H₄ 60 ppb)
Dissolution Oxygen : < 5 ppb (Deaeration : Ar gas)

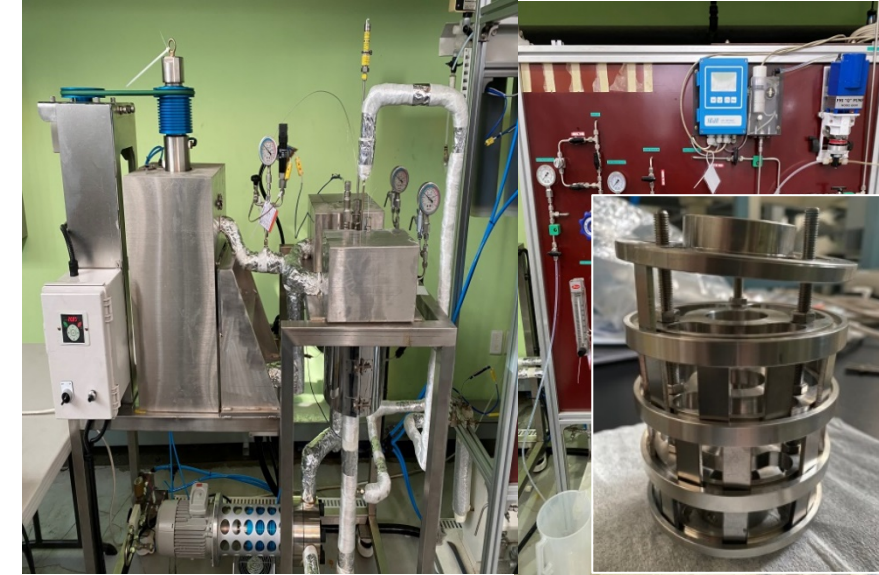
<Flow Accelerated Corrosion Test>

유속 : 6.0 m/s *700hrs*
pH : 9.3 (ETA, Hydrazine 60 ppb)
Pressure/Temp. : 1,200 psi / 235 °C
