Study of Stress Corrosion Cracking nucleation of Alloy 600 in primary water environment by EBSD and DIC

Jung-ho Shin ^{a,b*}, Dong-jin Kim ^a, Sung-Woo Kim ^a

^aKorea Atomic Energy Research Institute, (989-111 Daedeok-daero, Yuseong-gu, Daejeon, Republic of Korea)

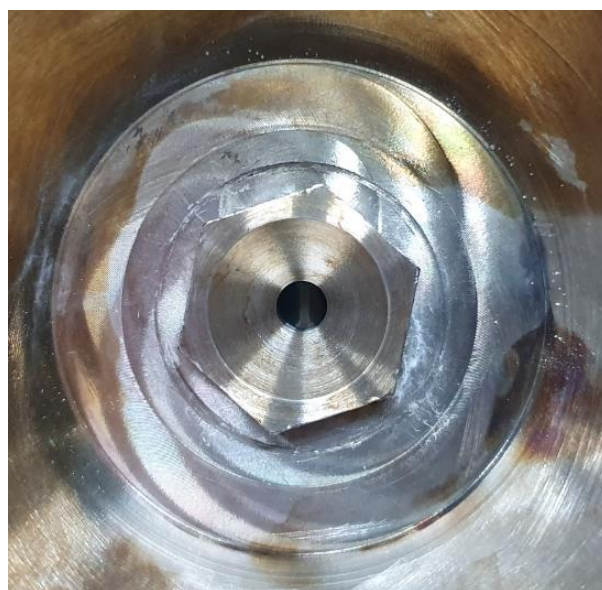
The slow strain rate tensile test (SSRT) is a common means to investigate stress corrosion cracking (SCC). In addition, we have developed a device that can observe the SCC of the specimen in in-situ by installing a diamond window view cell. Fig. 2 is a specimen observed through a diamond window view cell.

Fig. 2. Experimental specimens were observed through a diamond window view cell.
