Irradiation Properties of HANA Claddings tested in Halden Research Reactor

Hyun-Gil Kim*, Byung-Kwan Choi, Jeong-Yong Park, Yong-Hwan Jeong
Nuclear Convergence Technology Division, 1045 Daedeok-daero, Yuseong-gu, Daejeon, 305-353, Korea
*Corresponding author: hgkim@kaeri.re.kr

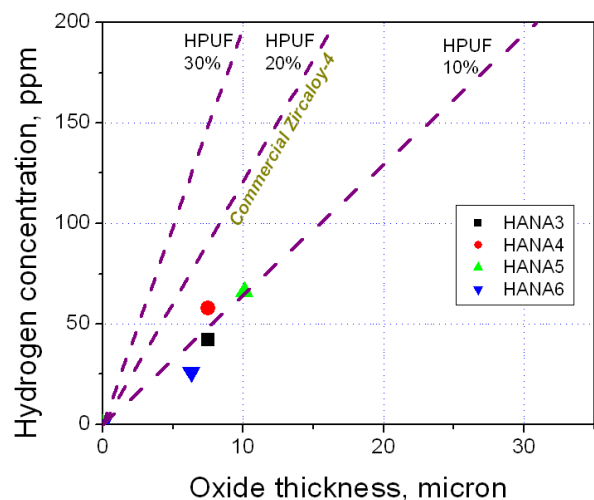
Fig. 1. Relationship between hydrogen concentration and oxide thickness of HANA claddings after three cycle irradiation

Hydrogen content analyses were performed to investigate the hydrogen pick-up behavior of HANA claddings during the irradiation corrosion test. The samples were cut from the center region of rods and were treated in HNO_3 solution to remove any remaining fuel particles on the inner surface, and then ultrasonically cleaned and dried. The analysis was performed using an ELTRA-OH-90 equipment. Fig. 1 shows the analyzed hydrogen content as a function of oxide thickness. The hydrogen content of HANA claddings was ranged from 26 to 66 ppm. From these values, HPUF (Hydrogen Pick-Up Fraction) of HANA claddings could be compared to the commercial Zircaloy-4 data and it is known that hydrogen pick-up resistance of HANA alloys is better than Zircaloy-4 alloy.

orientations. The oxide thickness of HANA claddings was measured in each image at three points and the average values were calculated and this result was shown in Fig.1.

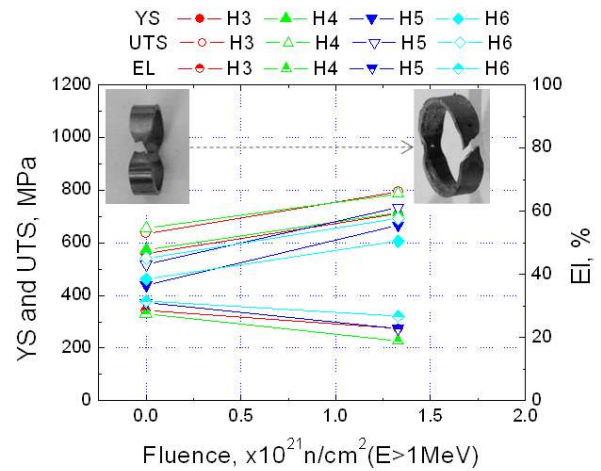
Fig. 3. Ring tensile test result of HANA claddings after three cycle irradiation

Tensile test at room temperature was done to obtain data on the mechanical properties such as the strength and ductility of cladding materials as function of irradiation fluence. Ring samples with a width of 2-3 mm were cut from the each fuel rod around the center of the axial direction. After cut the samples, the fuel is mechanically removed and treated in concentrated HNO_3 to remove remaining fuel particles and then the samples ultrasonically cleaned and dried. The testing was done on an Instron EZ50 tensile tester using a special tool designed for ring samples. The specimens were tested in the hoop direction at room temperature. The crosshead speed was 0.05 mm/min. The gauge length is not physically defined for ring samples, but a nominal gauge length equal to ca. 10% of the circumference is generally considered to be appropriate. The gauge length parameters for the specimens correspond to 3.0 mm. Fig. 3 shows the YS (Yield Strength), UTS (Ultimate Tensile Strength), and El (Elongation) values of HANA claddings after three cycle irradiation. When compared to the before irradiation results, YS and UTS was considerably increased, whereas, El was considerably decreased after three cycle irradiation. From the observation of fracture

type, cup and corn mode was changed to the 35° shear mode in HANA-3 cladding by three cycle irradiation. The variation of those results was changed with the alloy compositions in the HANA claddings. The HANA-5 cladding showed higher variation of strength and ductility than other claddings.
