Laser Decontamination of Surfaces Contaminated with Cs⁺ Ion

B. Baigalmaa^a, H. J. Won^{a*}, J. K. Moon^a, C. H. Jung^a, K. W. Lee^a and J. H. Hyun^b

^a Korea Atomic Energy Research Institute, 1045 Daedeokdaero, YuseongGu, Daejeon, 305-353, Korea

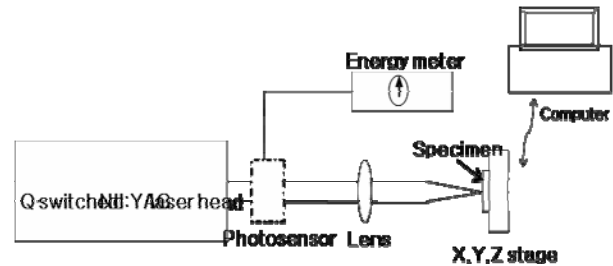
chemical composition. Fig. 1 shows a schematic view of the experimental apparatus.

Fig.1. Experimental apparatus for laser decontamination experiment.

Q-switched Nd:YAG laser fabricated in KAERI was employed. A pulse duration of Q-switched Nd:YAG laser was 14 ns. Maximum applied repetition rate was 17 Hz. The system emits fundamental wavelength at 1064 nm, and specimen was irradiated for 10, 42, 100 shots. A JSM-6300 scanning electron microscope (SEM) was employed to examine any laser induced alterations to the original surface. EPMA analysis was used to identify the

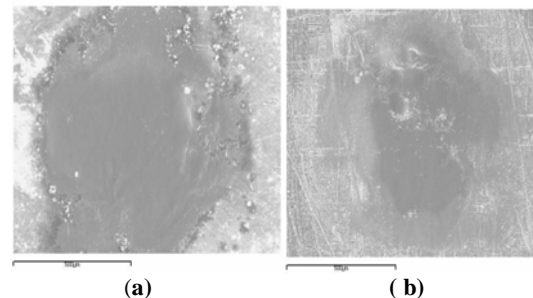
Fig. 2 shows the SEM photographs of a specimen after 42 shots of a laser irradiation. The high laser heating rate cause the significant amount of metal area to be melted. The chemical composition of the stainless steel surface as shown in Fig. 2 is listed in Table 1. The Cs⁺ ion content at A is 0.08, B is 0.0 atomic percent, respectively.

Fig.2. SEM photographs of stainless steel surface contaminated with (a)CsCl, (b) CsCl+KOH after 42 laser shots.

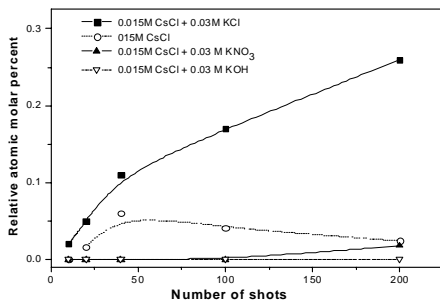
Fig. 3 shows the relative atomic molar percent of Cs⁺ ion on stainless steel surface after laser irradiation. As shown in Fig. 3, Type 304 stainless steel specimens were contaminated with 4 kinds of Cs⁺ ion solutions. The relative atomic molar percent of Cs⁺ ion in Fig. 3 is listed in Table.1. All the tests were performed at the pulse energy of 450 mJ/pulse and the repetition rate of 17 Hz. Contrary to the Cs⁺ ion content of the stainless steel specimen surface before laser irradiation, negligible amount of Cs⁺ ion is found after laser irradiation. This means that all the Cs⁺ ions was ablated by a laser application. These phenomena can be explained by two reasons. 1) As the Cs⁺ ion is a semi volatile element, Cs⁺ ion evaporated at a high temperature during a laser application. 2) Fe, Ni, and Cr which are the main elements of stainless steel were ablated thermally by a laser irradiation [1]. The Cs⁺ ion was concurrently ablated.

Fig. 3. Relative atomic molar percent of Cs⁺ ion after laser application against the number of laser shots, 57.3 J/cm² and 14 shots/sec.
