Feedback Experience from Decommissioning of Uranium Conversion Plant

D.S. Hwang*, K.I. Lee, Y.D. Choi, J.K. Moon
KAERI, Daeduck-daero, Yuseong-gu, Daejeon 305-353, Korea
*Corresponding author: dshwang@kaeri.re.kr

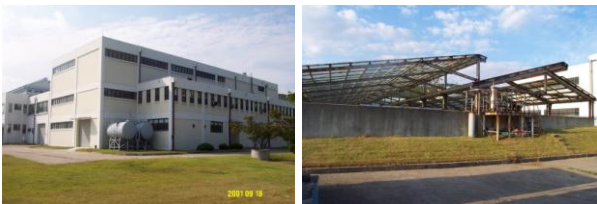
Fig. 1. UCP and lagoon

UCP was used to manufacture 100 tons of UO_2 powder for the Wolsong-1 CANDU reactor and has been shut down and minimally maintained for the prevention of a contamination by the deterioration of the equipment. The conversion plant has a building area of 2916 m^2 and two main conversion processes. An ADU (Ammonium Di-Uranate) and an AUC (Ammonium Uranyl Carbonate) process are installed respectively in the backside and the front side of the building. UCP has two lagoons, which is to store all wastes generated from the plant operation. Sludge wastes stored 150 m^3 and 100 m^3 in Lagoons, which was two ponds constructed by concrete structure. In 2000, the decommissioning of the plant was finally decided upon and a decommissioning program was launched to complete by 2010. In the middle of 2004, a decommissioning program obtained the approval of the regulatory body and decommissioning activities started. The project was completed at the first half of 2011 with a total budget of ₩12 billion.

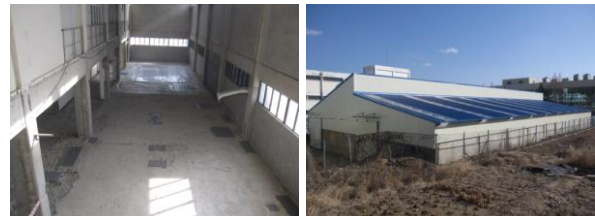
Fig. 2. UCP after decommissioning and remodeled lagoon

The major compounds of the lagoon sludge waste were ammonium nitrate, sodium nitrate, calcium nitrate, and calcium carbonate, and natural uranium of 1 wt%. The sludge waste from the lagoon was treated using a thermal denitration process. The lagoon sludge waste of 300 tons was treated completely. This process reduced the sludge volume by 70%. The lagoon was decontaminated and remodeled for use as a waste storage facility.
